5101-131
Low-Cost
Solar Array Project

Photovoltaic Module Soiling Studies May 1978 - October 1980

A. R. Hoffman
C. R. Maag

November 1, 1980

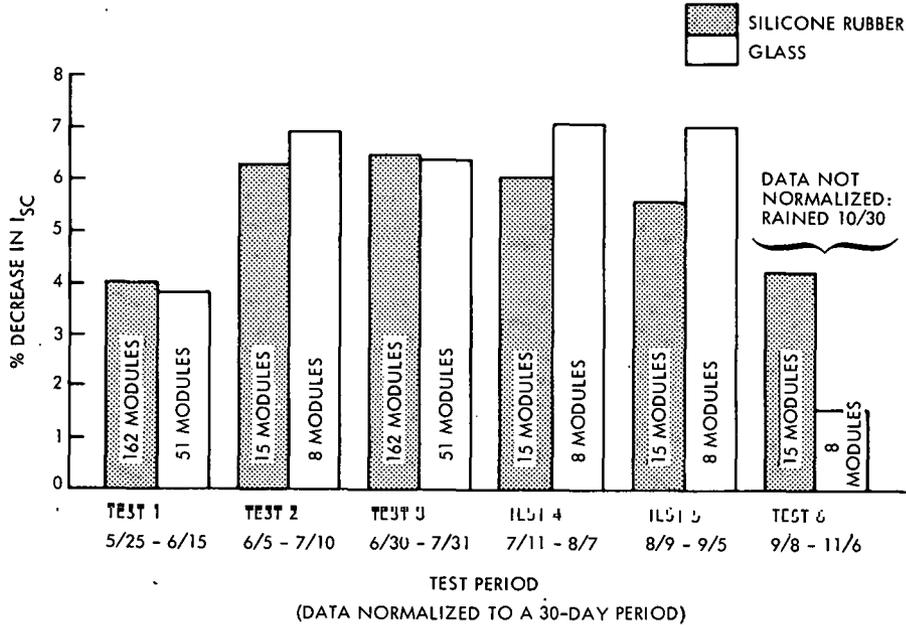
Figure 1. Electrical Performance Degradation of Modules During Rain-Free Periods in Pasadena CA (1978)

Typical average short-term electrical performance degradation of 6 to 7% per month has been observed during rain-free periods in Pasadena CA, independent of surface materials (Figure 1). Over long periods (about 6 mo) the net accumulation, including effects of natural removal, results in measured degradation ranging from 2% for glass-surfaced modules in Arizona to 60% for silicone-surfaced modules in high-pollution city locations (Cleveland and New York City).

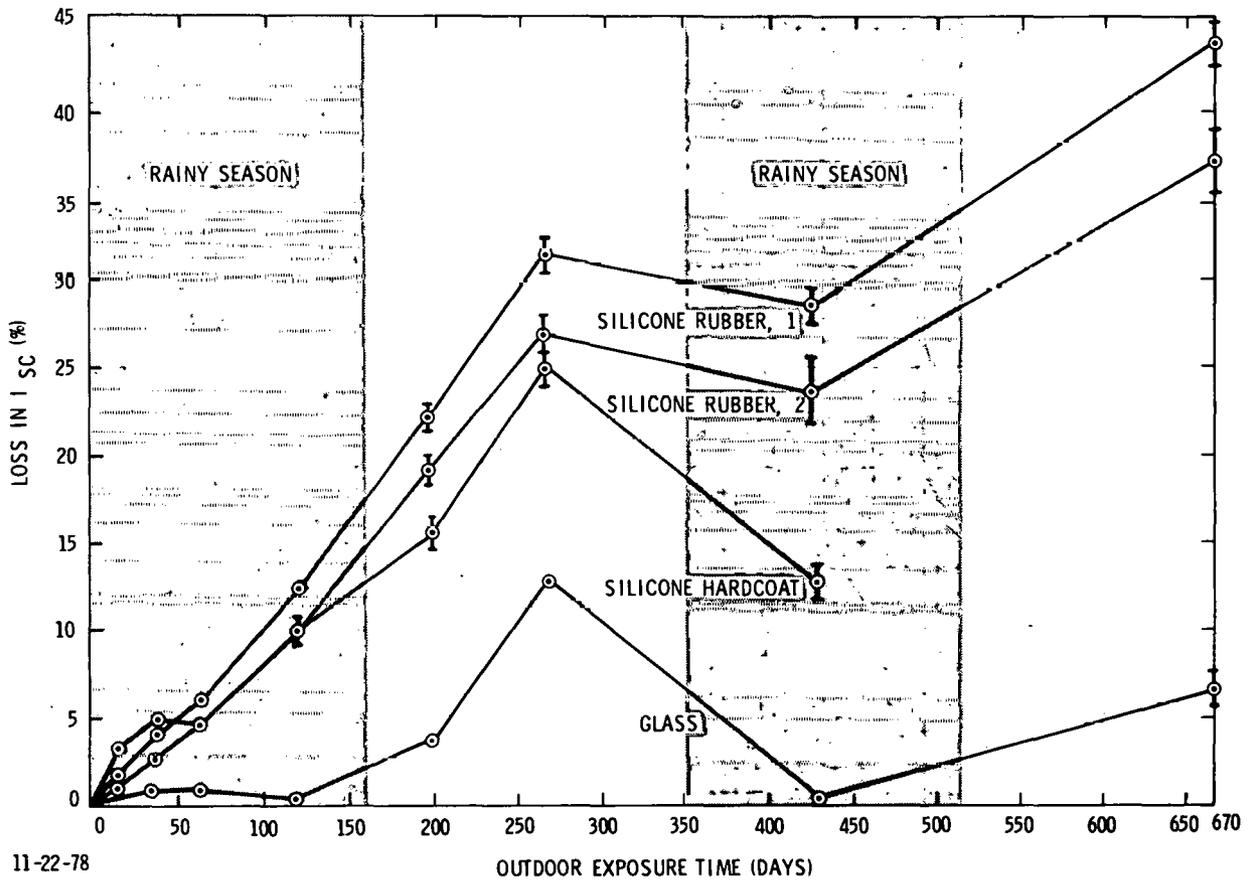
Figure 2. Module Soiling Without Cleaning: Pasadena, CA

The percentage changes in P_{max} and I_{sc} for various modules at various sites throughout the country are given in Appendix A. From the examination of the tabulated data and of Figures 1 and 2, the following observations are made:

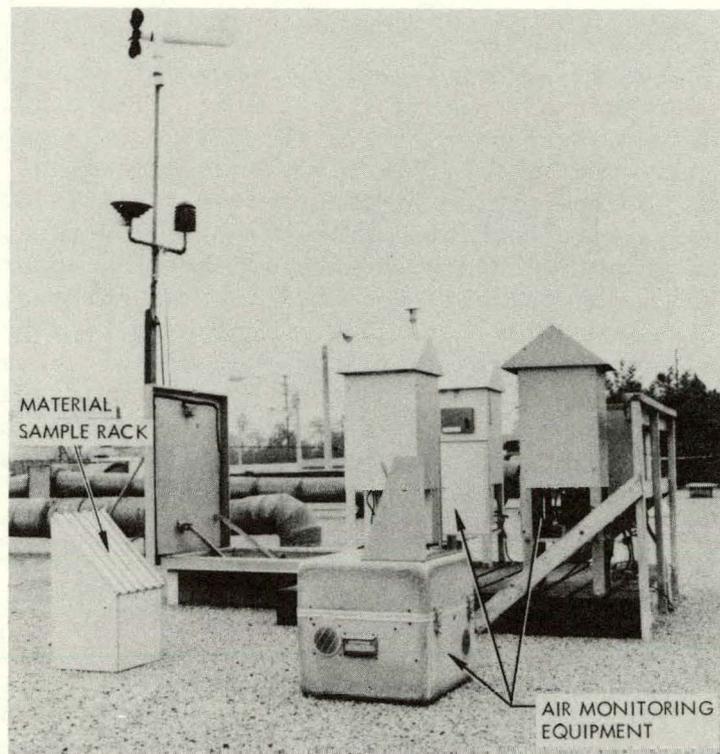
Figure 3. Material Samples at SCAQMD Air Monitoring Site, Pasadena CA

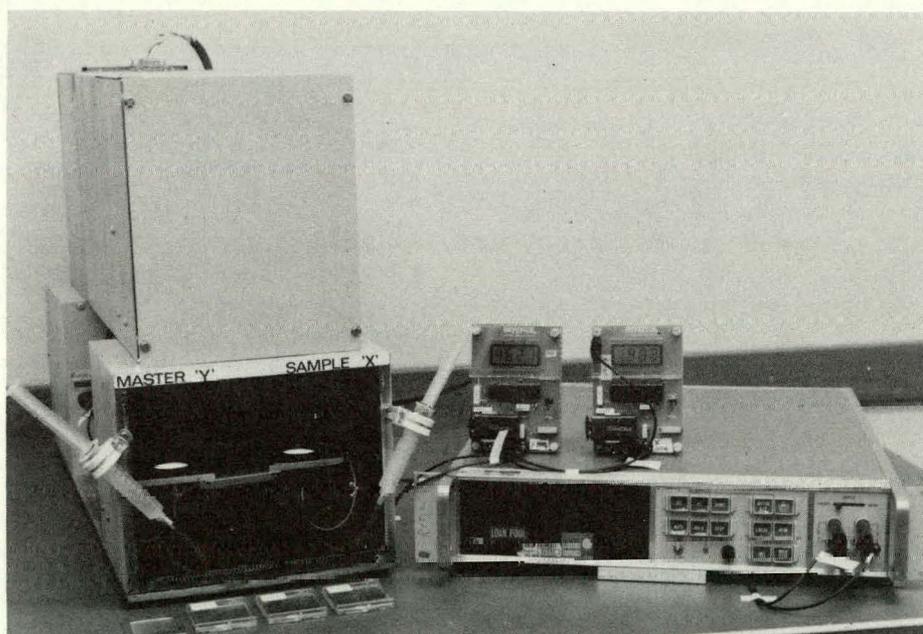
Figure 4. Relative Normal Hemispherical Transmittance Measurement Apparatus

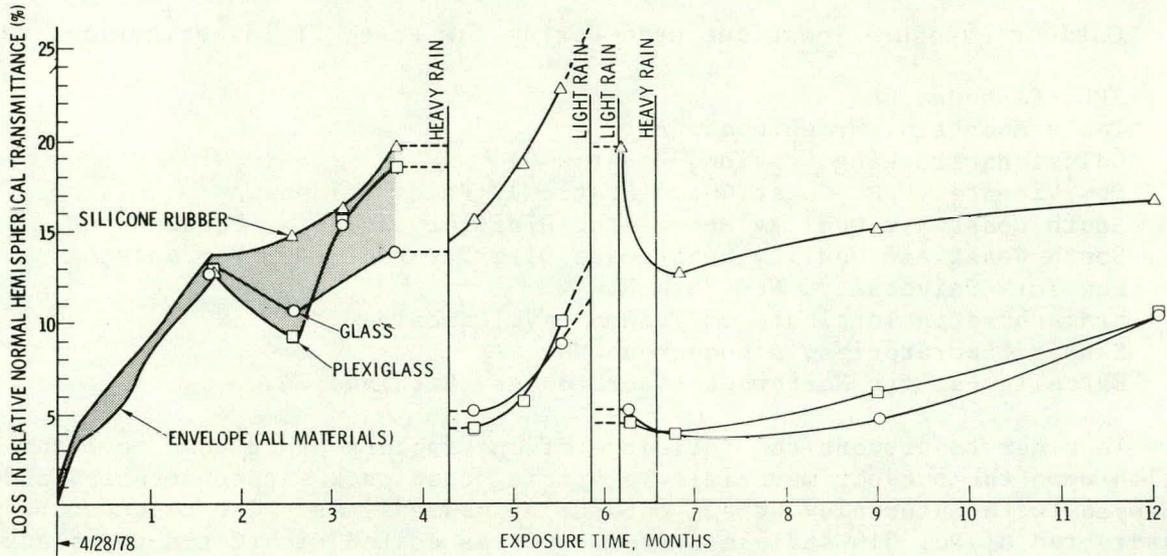
Figure 5. Relative Transmittance of Materials at SCAQMD Site, Pasadena

The results from this study for silicone rubber, glass, and Plexiglas are shown in Figure 5. During the first month and a half the rate of soil accumulation on all materials as measured by the loss of relative transmittance was about 7% per month. The dip at 82 days could not be explained by any meteorological phenomenon, although fog and possible condensation could have caused some cleaning. However, after the first significant rain of the Southern California rainy season the Plexiglas and glass samples were more extensively cleaned than was the silicone rubber. Dirt began to accumulate and the obscuration on all materials increased until another rain occurred. This pattern continued throughout the sampling period. The conclusions drawn from this experiment include the following:

- (1) The rate of soil deposition is material-independent; the effectiveness of natural removal by rain is material-dependent.
- (2) Average losses in relative transmittance over a one-year period were 16% for silicone rubber, and 7% to 8% for glass and Plexiglas.
- (3) If exposed materials are heavily soiled, rain can cause improvements in transmission of 10% to 15% for glass and Plexiglas and 5% for silicone rubber.

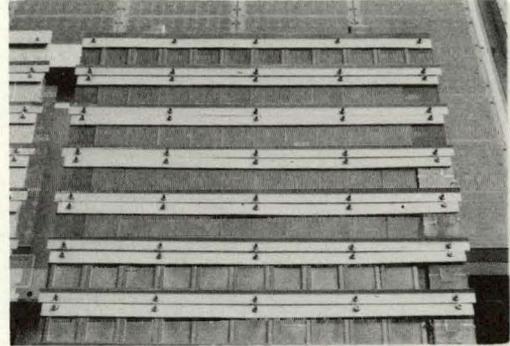
Test Rack With Material Samples

Figure 6. Some Outdoor Exposure Sites and a Typical Sample Test Rack

In order to prevent the influence of any factors other than environmental action upon the outdoor materials, a special test rack was constructed and deployed (with materials) at all outdoor exposure sites. The test rack was constructed of No. 316 stainless steel and was coated with Cat-a-Lac black epoxy, a high-quality aerospace (flight quality) black paint. In addition to the all stainless-steel construction hardware used, rain channels were incorporated between rows of materials samples to prevent draining of naturally removed (washed away) dirt over lower samples. The surface of the test rack was painted black for two reasons: to prevent photolysis of the samples from the double pass phenomenon (bare stainless steel has a relatively high spectral reflectance below 4000 Å) and to achieve an equilibrium temperature under the samples somewhere near that of an exposed module; the solar absorptance-to-hemispheric emittance ratio (α/ϵ) for the black paint and for the typical solar cell is near unity. Figure 6 shows a sampling of the outdoor exposure sites and one of the test racks.

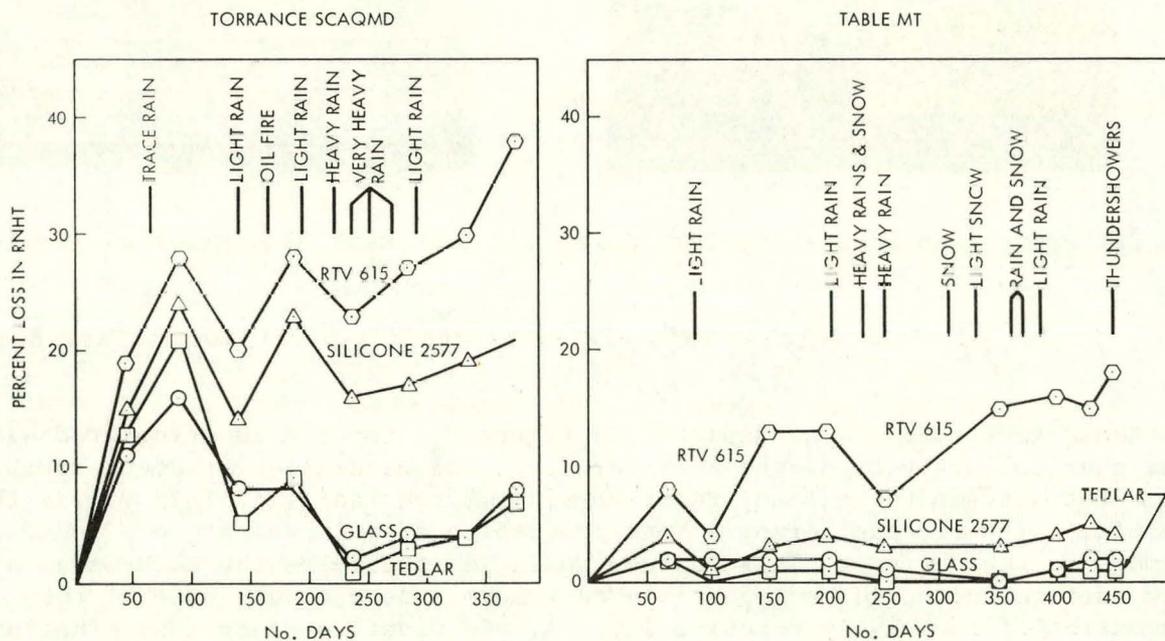
Figure 7. Percentage Loss in RNHT of Materials Exposed at Two Locations

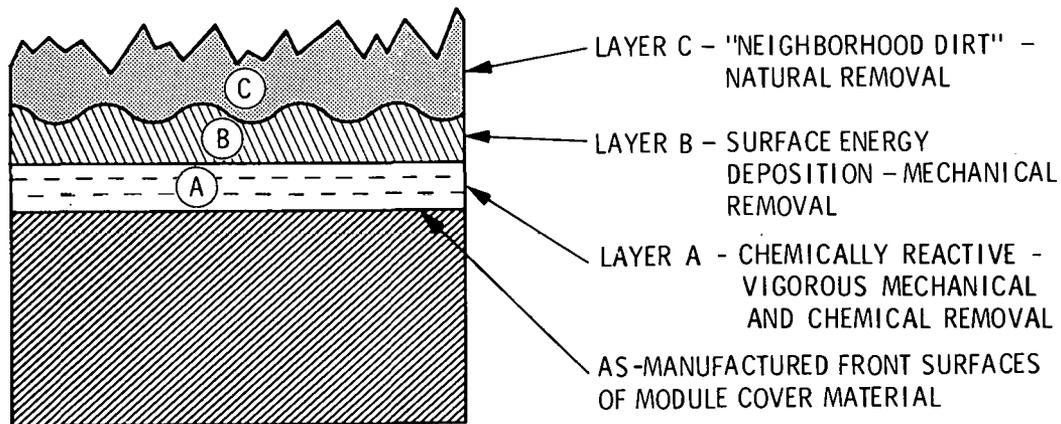
Figure 8. Three-Layer Soiling Mechanism

removing Layer B, an almost complete recovery should occur. This is consistent with field observations. Theory also suggests that if no reactive oxidation occurs (i.e., no reactive sites exist), no Layer A can be formed. This appears to be the case for surfaces such as glass and acrylic materials.

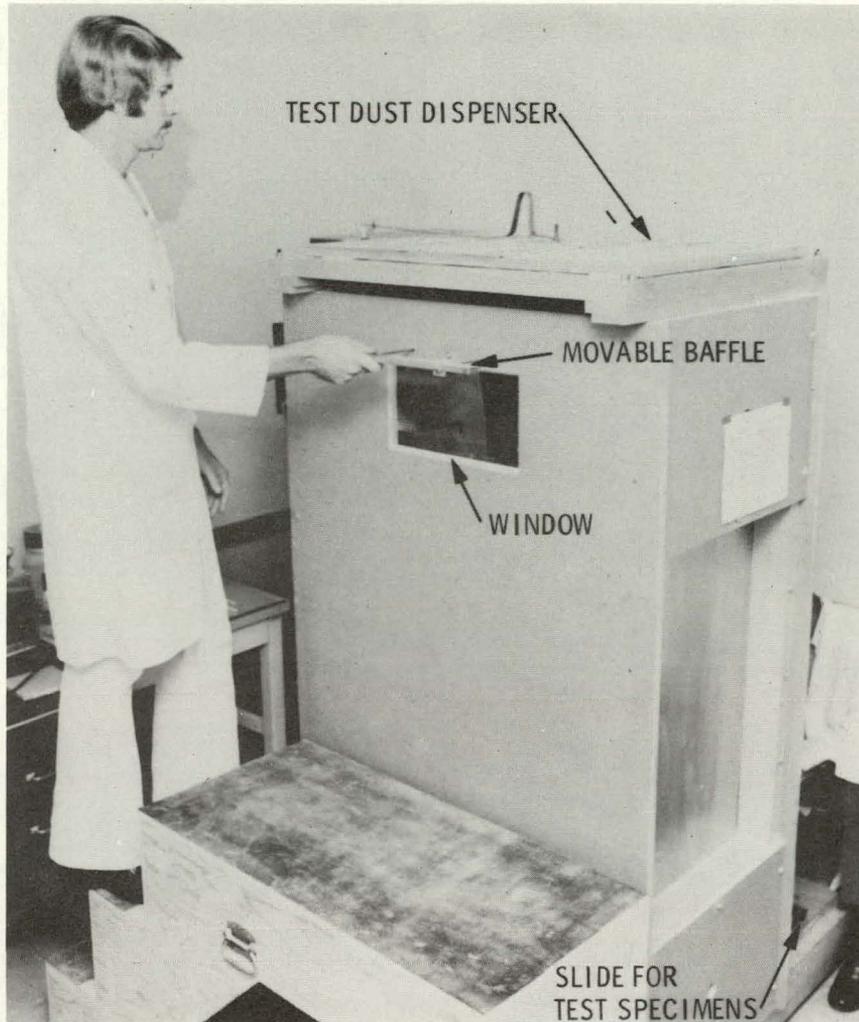
Figure 9. Experimental Particle Deposition Chamber

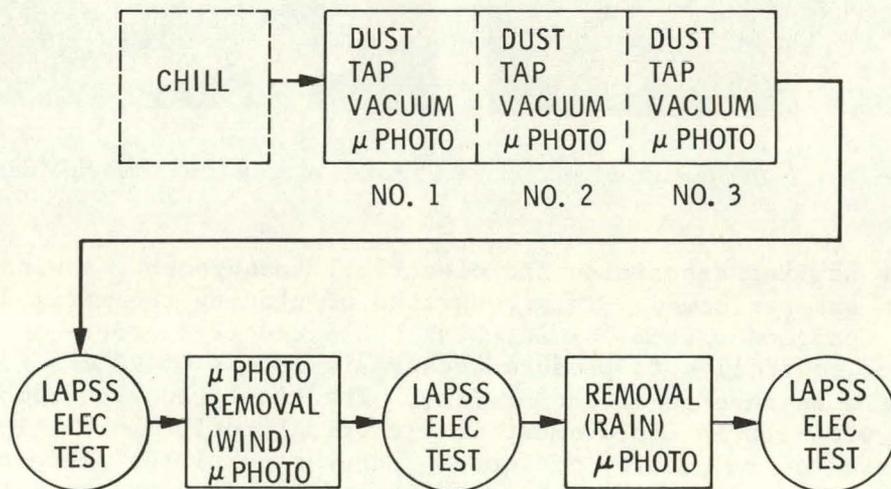
Figure 10. Laboratory Minimodule Dust Test Sequence

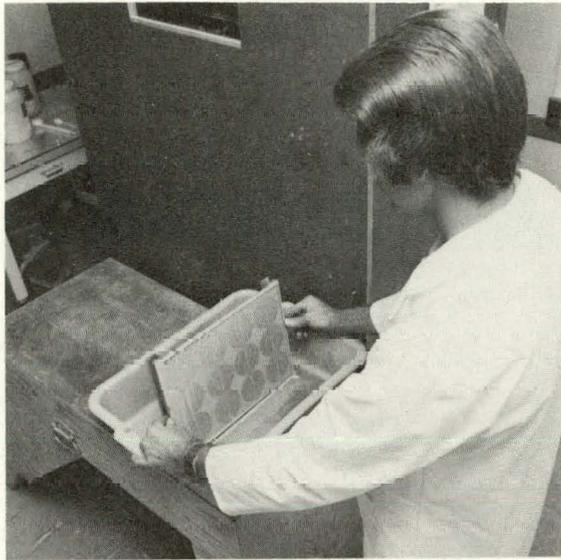
Figure 11. Tapping Step

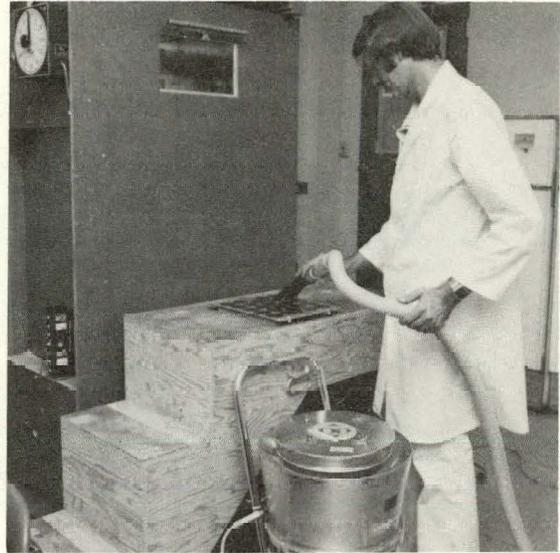
Figure 12. Vacuuming Step

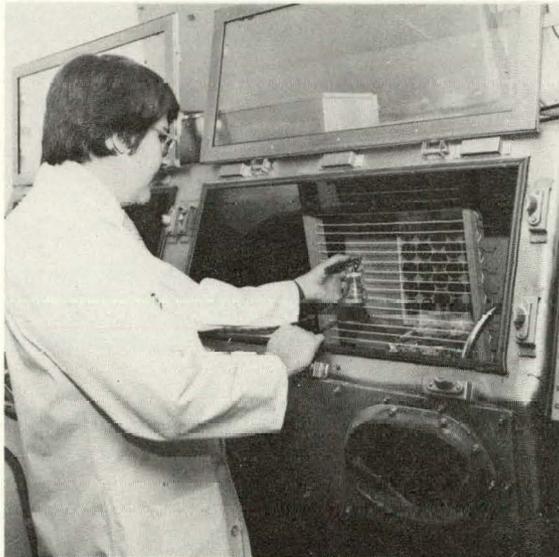
Figure 13. Smogging Step

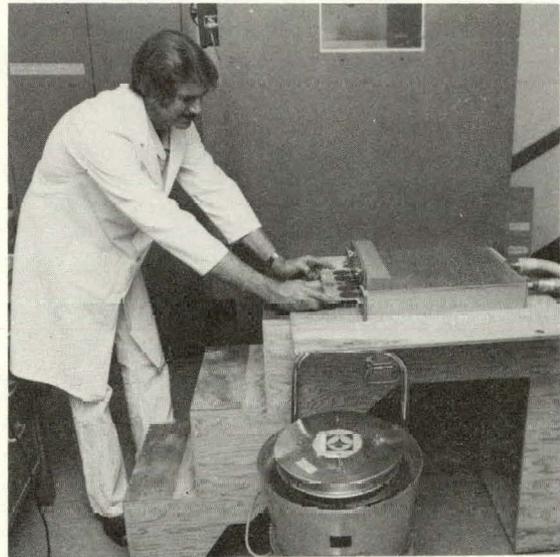
Figure 14. Wind-Removal Simulation

After soiling deposition and electrical measurement, a wind-removal simulation was performed. This consisted of placing the minimodule in a specially designed vacuum box in which the standoff distance at the entry orifice was controlled to produce steady air speeds of 27 m/s (60 mph) (Figure 14) near the knife edge of the orifice. The simulated wind removal seems to result in very little improvement in electrical performance. This is probably attributable to the paucity of loosely adhered particles present on the surface at the conclusion of the deposition procedure that concluded with a vacuuming. In the field, winds could remove loosely adhered particles

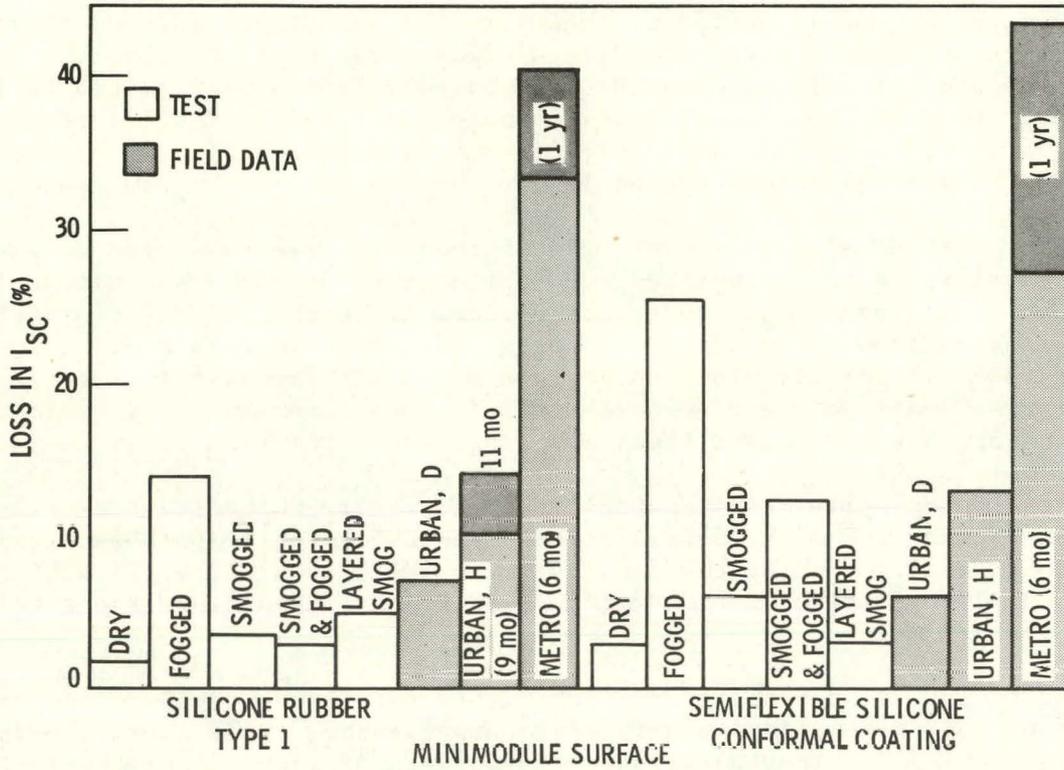
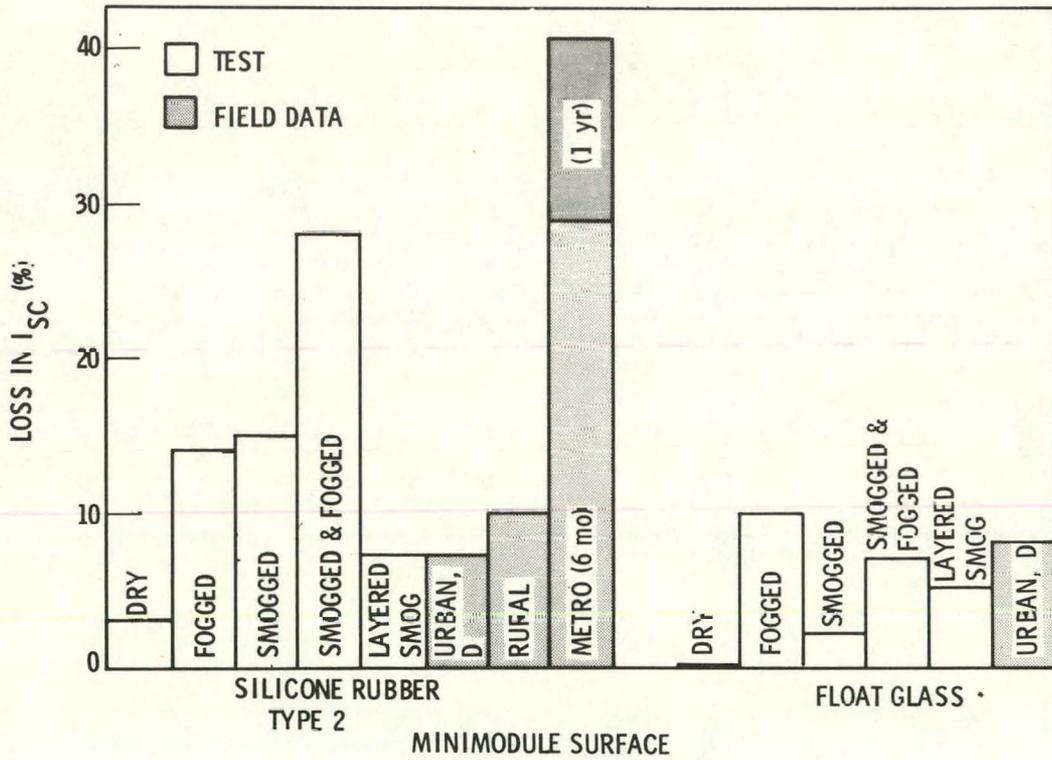
Figure 15. Relative Retention of Particles on Module Surfaces in Laboratory and Field Tests

When the relative retention of the artificially dusted test samples are compared (Figure 14) with the field "by cleaning" data in Appendix A, the laboratory results envelop the field data, except for urban areas with high pollution. The absolute percentage changes are different, but the trends appear to be similar.

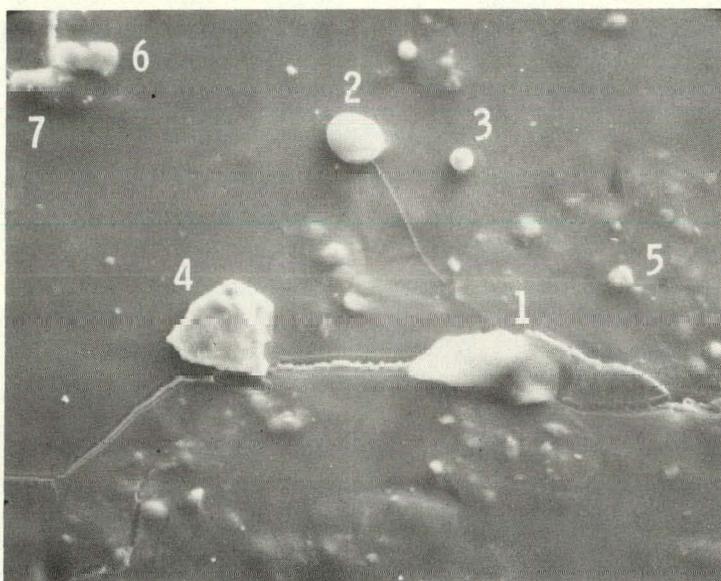
Particle No.	Identification
--------------	----------------

1	Contains Si, S, Cl, K, Br
2	Pollen?
3	Clay
4	Quartz
5	Paint
6	Water Scale
7	Water Scale

Identification of particles on a material sample (silicone rubber) cut from a module exposed at Cleveland, using SEM and energy-dispersive spectroscopy, was made. The results are depicted in Figure 16.

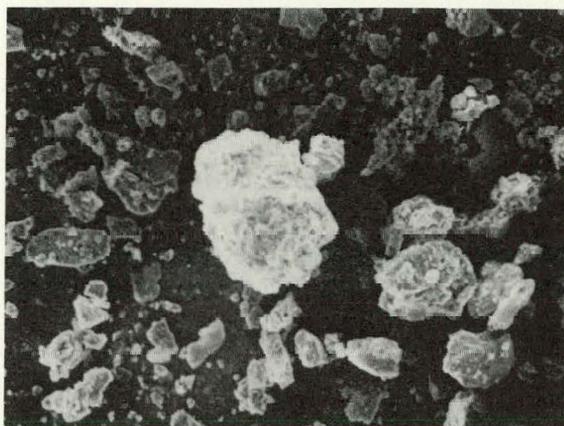
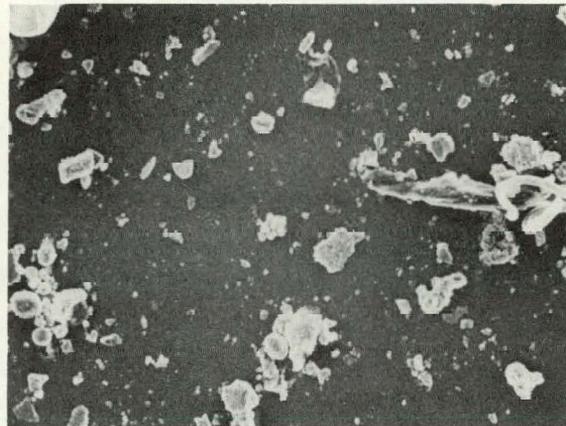
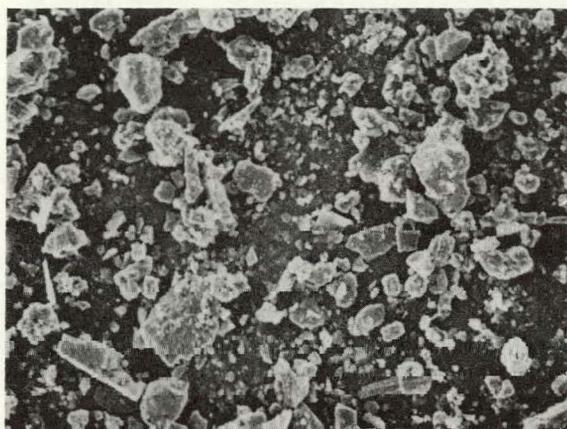
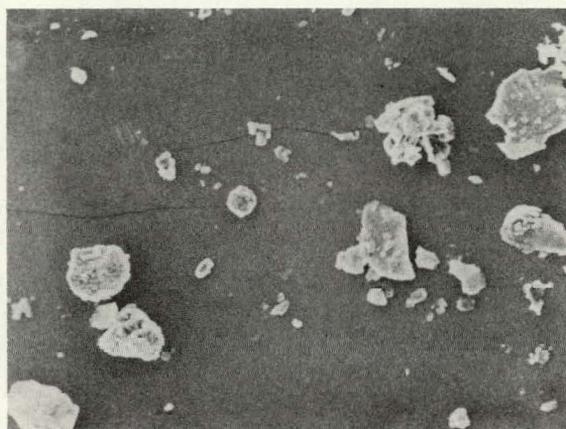
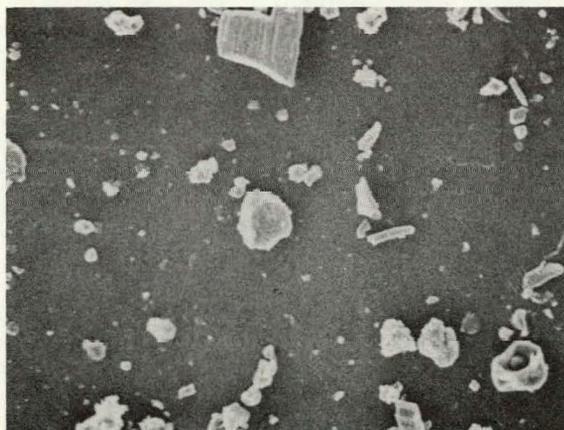
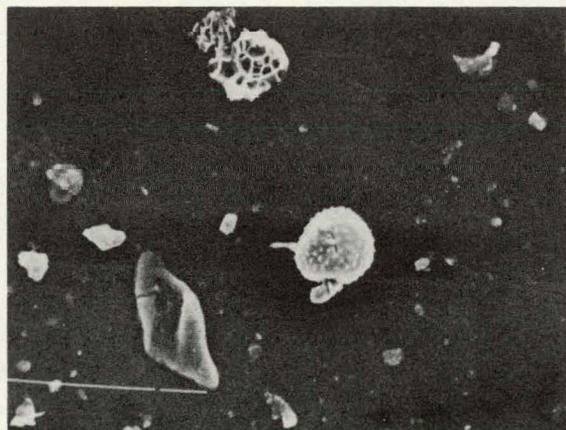
As mentioned above, non-destructive tests are being performed on all RTV 615 samples. Complete data will be presented in a forthcoming test report; presented here are the results to date. Figures 17a through 17e show 400x magnification of particulate matter deposited on the RTV 615 after 200 days at each of the five California sites. Figure 16f, 1000x, shows the same, clearly revealing the presence of pollen (probably conifer) and diatomaceous earth. An initial assessment tends to indicate that the predominant contaminating species in the Southern California locale is kaolinite.
