Uses of infrared thermography in the Low-Cost Solar Array Program

Stuart D. Glazer
Applied Mechanics Technology Section, Jet Propulsion Laboratory
California Institute of Technology, Building 157 Mail Stop 102
4800 Oak Grove Drive, Pasadena, California 91109

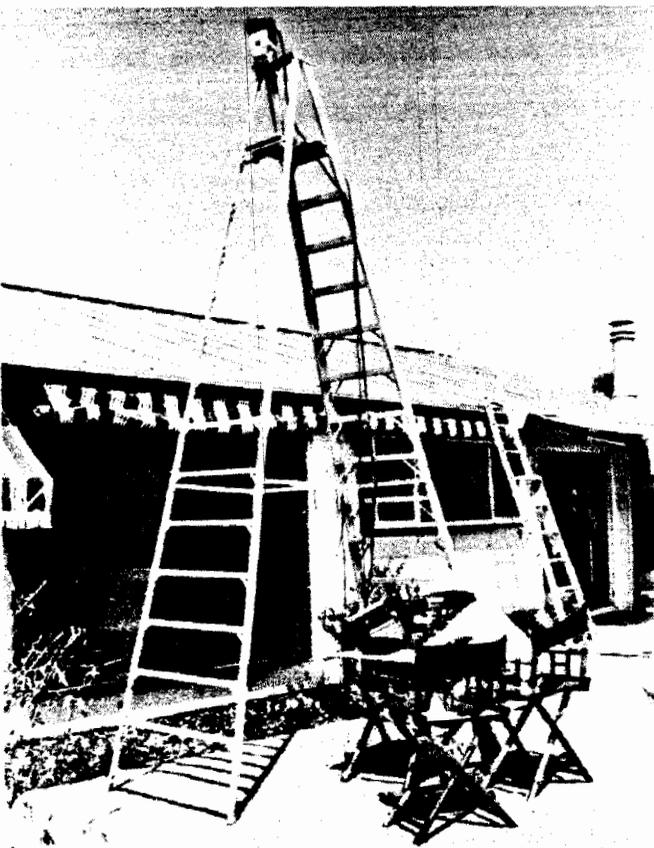
Figure 10. Roof-mounted photovoltaic array at John Long residence, showing infrared scanner placement.

A 3-kW_p array of solar cells was installed on the roof of a residence in Tempe, Arizona, by John Long, a home developer. The modules were of a new design, not made by the manufacturer of the modules at Mt. Laguna. Figure 10 illustrates how the infrared scanner was secured to a remotely operated pan/tilt-head that was placed atop a tall ladder adjacent to the rooftop photovoltaic array. This arrangement permitted a convenient and thorough thermographic inspection from the ground.

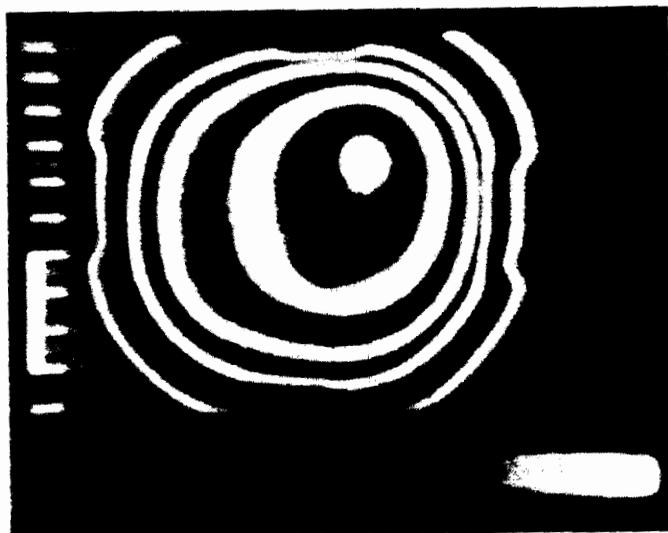
Figure 12. Multiple-exposure thermograph of reverse-biased cell.

A series of reverse-bias cell-heating tests were performed at JPL according to the designated test specification. Modules of several manufacturers and design types were examined to compare thermal performances. In these tests, cell temperatures were monitored by thermocouples placed in the center of the cell by drilling through the module substrate layer. Classical thermal modeling suggests that maximum cell temperature should occur at the center, but localized cell reverse-bias voltage-breakdown mechanisms, which are greatly dependent on random microflaws and temperature, may cause highly asymmetric cell heating. The JPL infrared radiometer was also used in these tests. The scanner was set up to view the front surface of each module being tested, and thermal gradients observed on the cell and module were recorded. Figures 12 and 13 are sample thermographs of two different reverse-biased cells under test. In these presentations several different isothermal regions are artificially highlighted in white. The contour map appearance is obtained by making multiple photographic exposures at each of several known isothermal levels determined by the position of the cursor on the graticule at the left edge of the picture. All isothermal regions were referenced to a controlled black-body temperature source (not shown); after correction for surface emissivity and background temperature, they may be identified within an estimated 4°C over a total range of 160°C. Note that thermal patterns obtained in this way are strictly valid only at the module superstrate (cover) of the front surface, since it is opaque to infrared radiation in the 8- to 12- μm wavelength band. Despite thin covers, temperature drops of several degrees may be expected between the cell and the superstrate front surface. Lateral heat transport through the superstrate is small, due to relatively low thermal conductance; hence, gradient patterns observed with the infrared radiometer are considered to be reasonably accurate.
