ELECTROCHEMICAL DEGRADATION OF AMORPHOUS-SILICON PHOTOVOLTAIC MODULES*

G.R. Mon**
R.G. Ross, Jr.***

Jet Propulsion Laboratory/California Institute of Technology
Pasadena, California

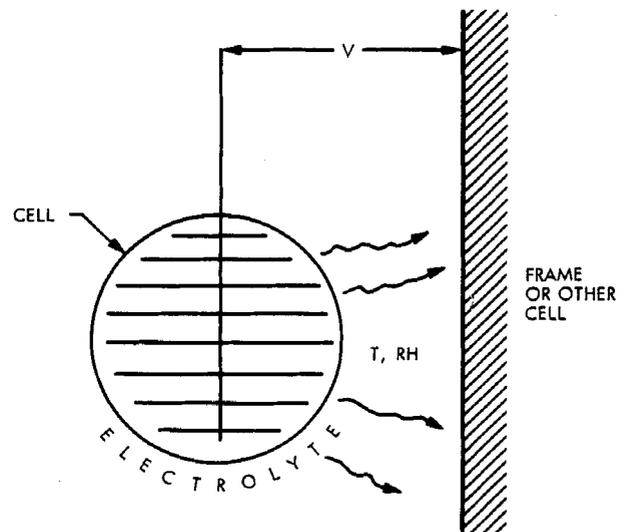
The fundamental principles of photovoltaic module electrochemical corrosion can be understood with the aid of Figure 1. Leakage current is composed of charge carriers that move under the influence of voltage and concentration gradients through the insulation, reacting with it and the cell and frame metals to produce corrosion products. Leakage current levels are determined in large part by the electrical conductivity of the insulation. This conductivity varies greatly with changing environmental conditions of temperature and relative humidity as indicated for

Figure 1. Corrosion Mechanism Overview

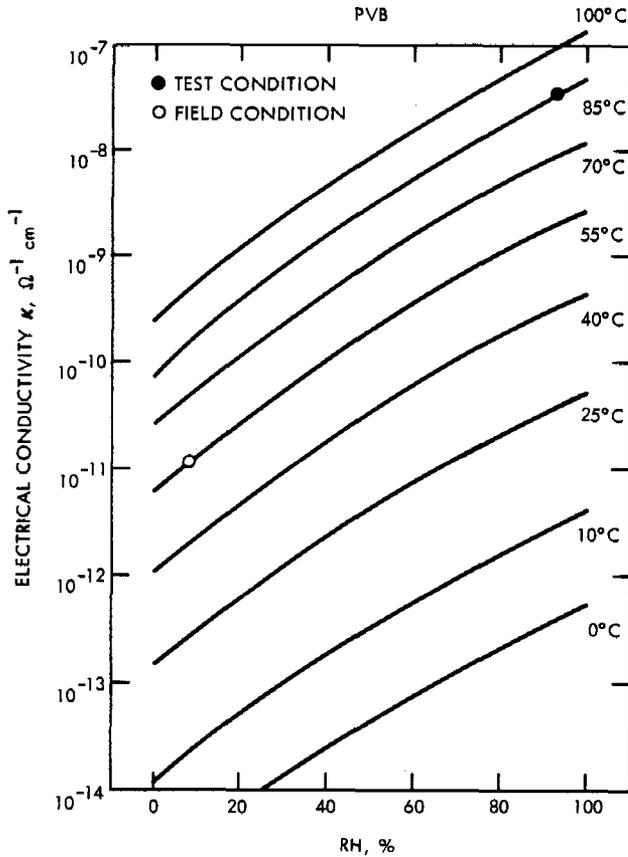
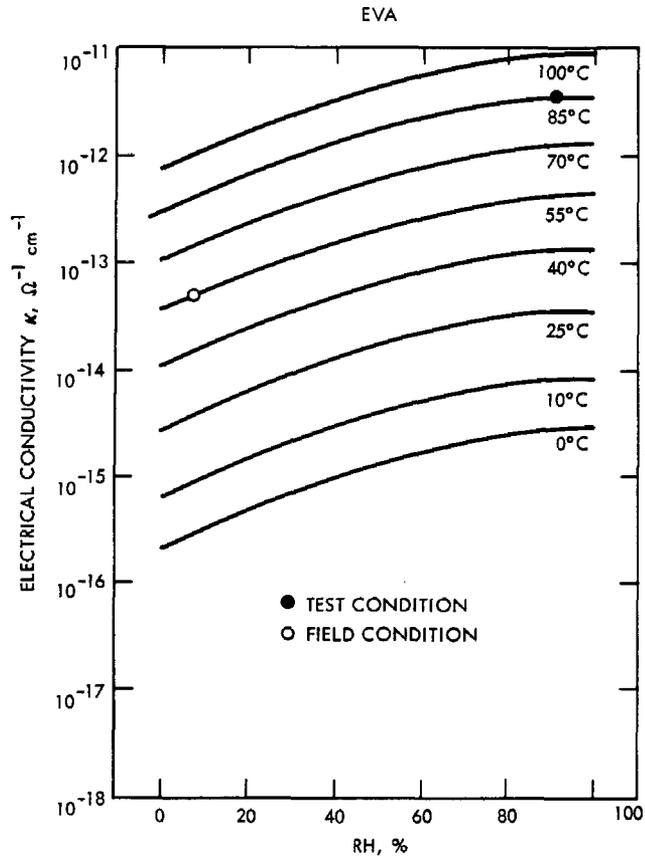
Figure 2. Bulk Electrical Conductivity of PVB and EVA

two popular photovoltaic insulation materials, polyvinyl butyral (PVB) and ethylene vinyl acetate (EVA), in Figure 2. Because of this high sensitivity to temperature and relative humidity, a typical 85°C/85% RH test environment, as used in this study, may have an acceleration factor of two to three orders of magnitude compared with field operating conditions. Also note that, for the same conditions of temperature and humidity, the conductivity of PVB is about three orders of magnitude greater than that of EVA.

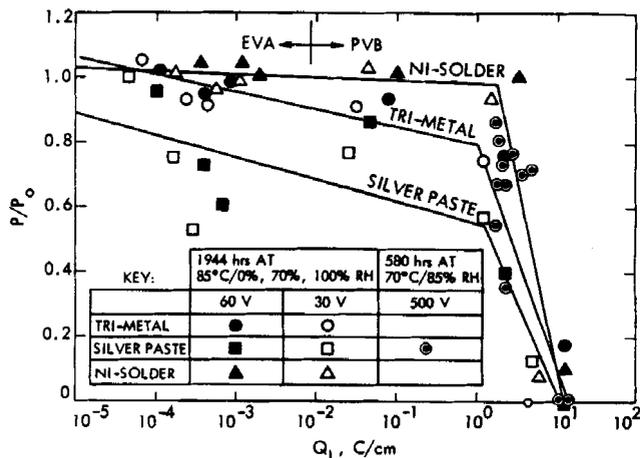
Leakage current integrated over time yields the charge transferred between the cell and the frame. The quantity of charge transferred is an important measure of the total degree of electrochemical corrosion and resulting damage, such as cell power output reduction. Figure 3 quantifies this relationship between total charge transferred and reduction of cell maximum power output for crystalline-silicon (C-Si) modules. As shown, 1 to 10 coulomb/cm of charge transferred between cell and frame are required to produce a significant level (approximately 50%) of cell failures. The assumption that equal quantities of charge transferred in laboratory and field environments produce equivalent electrochemical damage, and the use of reduced SOLMET weather data, enables the determination of equivalent laboratory and field exposure times (2).

Figure 3. Power Output Reduction Versus Accumulated Unit Charge Transfer for C-Si Cells

Figure 8 displays the general loss of cell I-V performance versus charge transferred for the tested α -Si cells. When comparing this plot with the corresponding one for C-Si cells in Figure 3, one is led to the conclusion that α -Si cells are somewhat less rugged than C-Si cells with respect to electrochemical corrosion. Qualitatively, the level of sensitivity would seem to be entirely consistent with achieving excellent long-term corrosion life with a good high-resistivity corrosion-inhibiting encapsulant such as EVA.

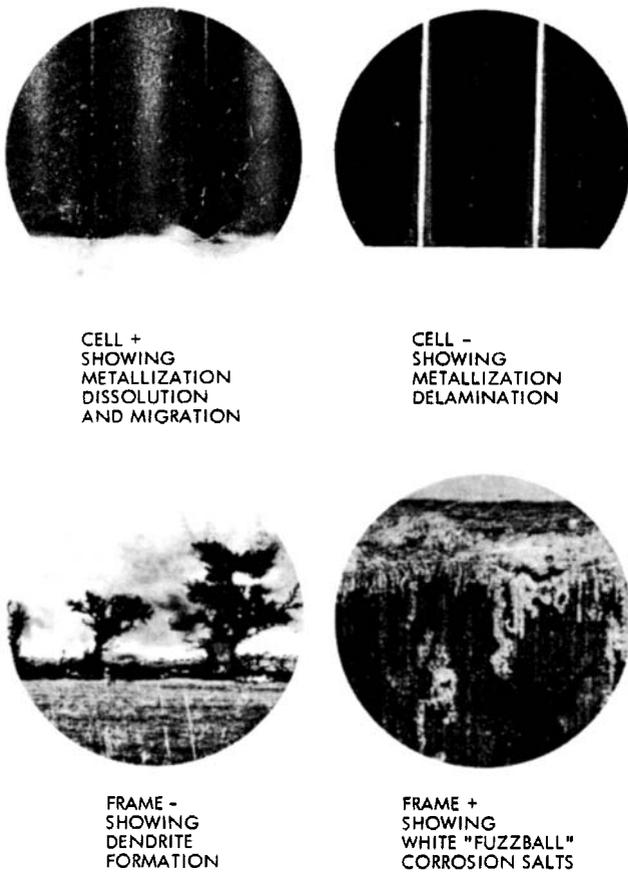
Typical corrosion observed in C-Si modules is depicted in Figure 4. With positive polarity

(cell positive relative to the frame), corrosion is characterized by loss of cell metallization and the formation of cathodic dendrites. The dissolved cell metallization ions have migrated to the frame, upon which they have deposited as dendritic crystallites. Typical corrosion in negative polarity exhibits less obvious characteristics to the naked eye, but microscopic examination reveals the formation of anodic corrosion salts and the evolution of gas bubbles at the cell's metallization-silicon interface, resulting in metallization delamination. Although the corrosion mechanisms in the two polarities differ, the degradation rates are comparable (3).

Figure 4. C-Si Cell Electrochemical Degradation in Two Polarities 500V, 580 h at 70°C/85% RH

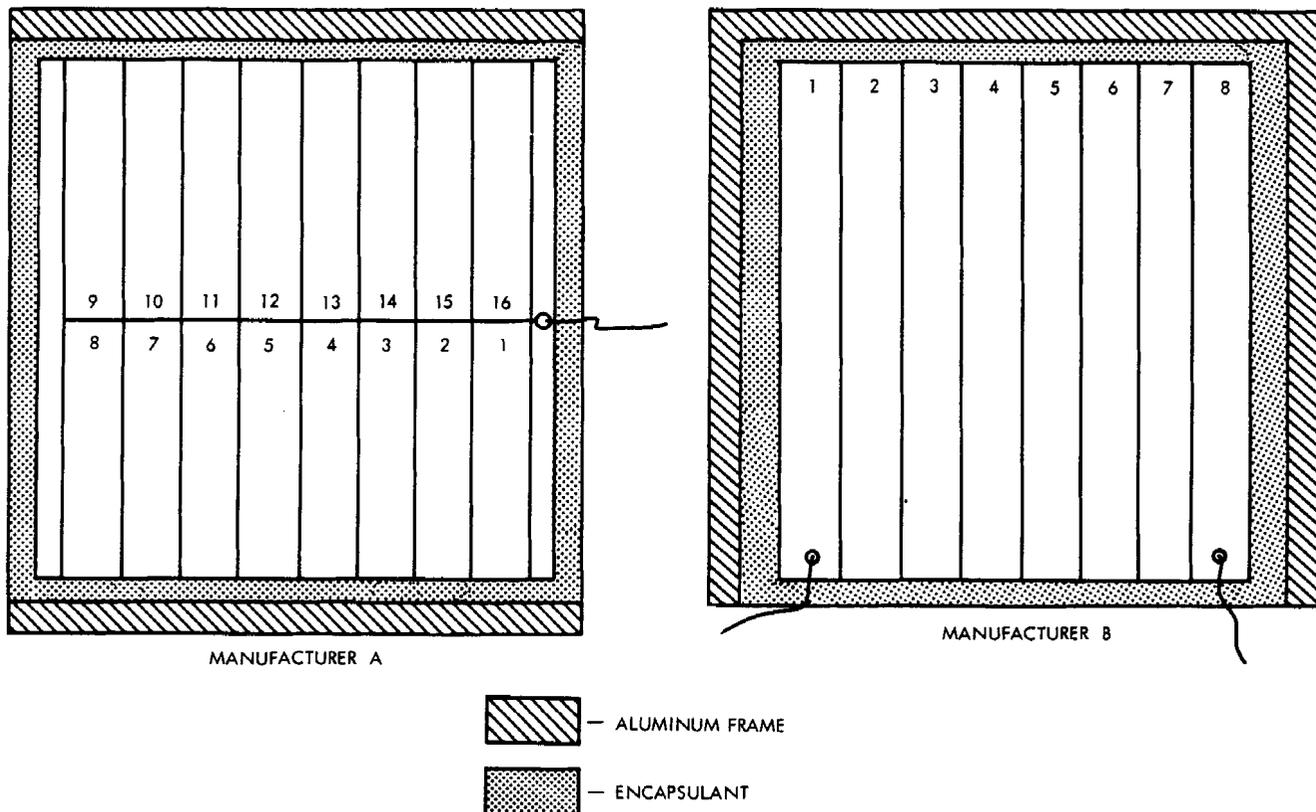
Amorphous-Si submodules containing sixteen and eight cells, respectively, were obtained from two leading manufacturers, referred to as A and B (Figure 5). In the 16-cell submodule, all the

cells are in parallel, sharing a common front electrode — the SnO₂ layer deposited on the underside of the glass superstrate. The eight-cell submodule consists of series-connected cells

with typical monolithically deposited overlapping interconnections.

To provide a controlled and known electrochemical environment, the submodules were each surrounded by a peripheral aluminum frame (Figure 5) to serve as the ground electrode, and the submodule-frame combinations were encapsulated in two well characterized encapsulants: PVB and EVA. Unprotected PVB, with its high conductivity, provides a highly accelerated corrosion environment and allows significant levels of charge transfer to be achieved in a rational test duration. EVA, with its high resistivity, more accurately reflects desirable field charge-transfer rates.

Figure 5. Amorphous Module Configurations

In a companion paper at this conference (4), it is pointed out that the minimum-resistance leakage current paths that control corrosion rate generally involve ion transport to and along material surfaces and intermaterial interfaces. In C-Si modules, where the cells are isolated from the environment by encapsulation on all sides, the corrosion rate is determined by the resistance of the encapsulant layer between the cell and the module rear surface. The rear surface, then, acts as a low resistance short to the module frame. The α -Si test specimens discussed here, and illustrated in Figure 5, have a similar encapsulant thickness isolating the submodule active surface from the frame member.

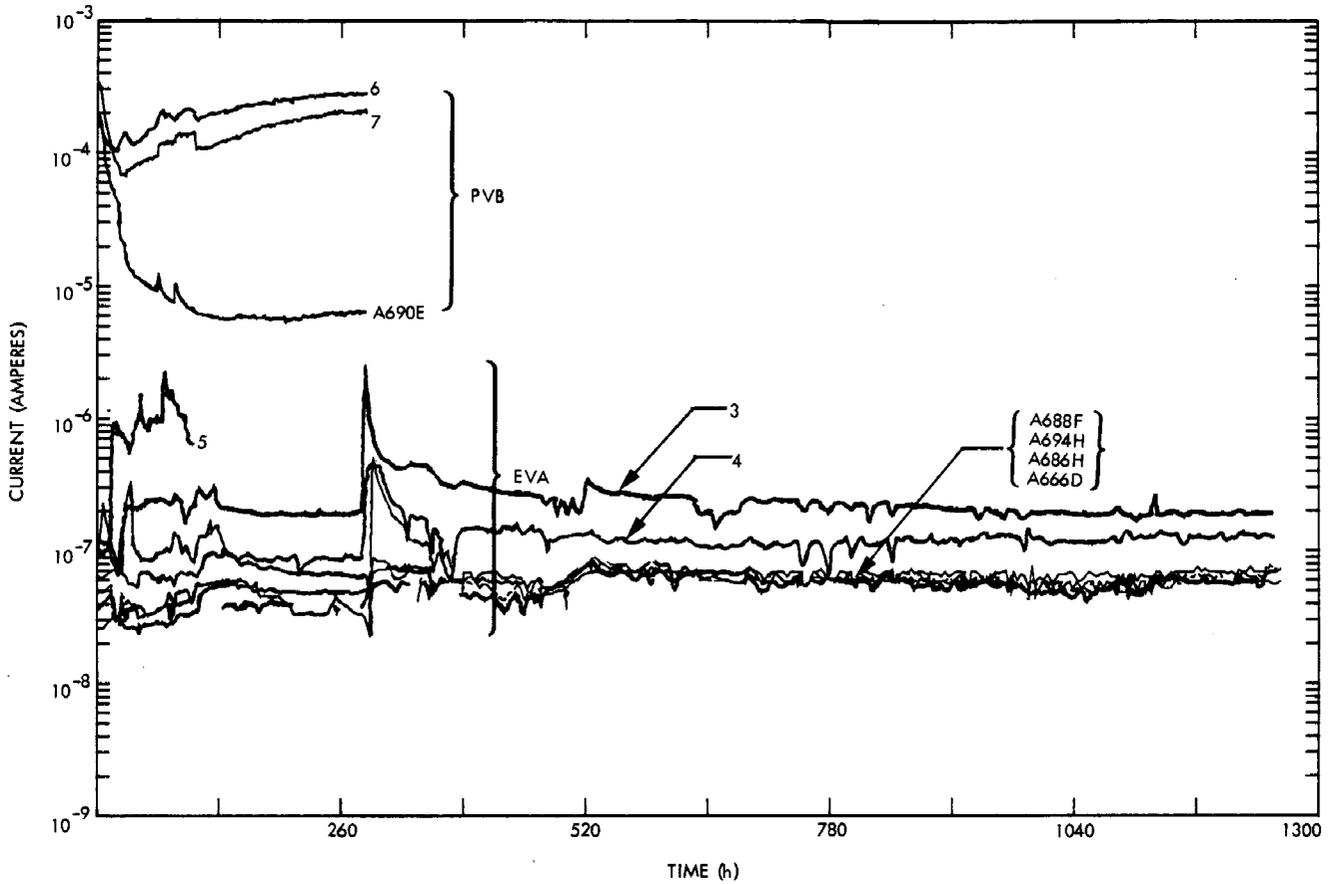
After encapsulation, all of the cells of each module were electrically shorted together with external jumper wires to become one electrode; the frame became the second. The specimens were then exposed, some for more than 1200 hours, in an environmental chamber at 85°C/85% RH, with 500 volts applied between cells and frame. Five modules from each of two manufacturers, A and B, were tested. Table 1 presents the individual module data including encapsulant, polarity of applied voltage, cell-frame gap spacing, and degradation observations. Automatic computer control of the test allowed the leakage current of each module to be monitored (Figure 6) and its integrated charge transfer to be continuously computed. Separate wires to the individual cells of each module also allowed cell I-V data to be acquired at periodic chamber down-times (Figure 7).

Figure 6. Amorphous Modules: Leakage current Versus Time of Exposure at 85°C/85% RH, 500 Volts

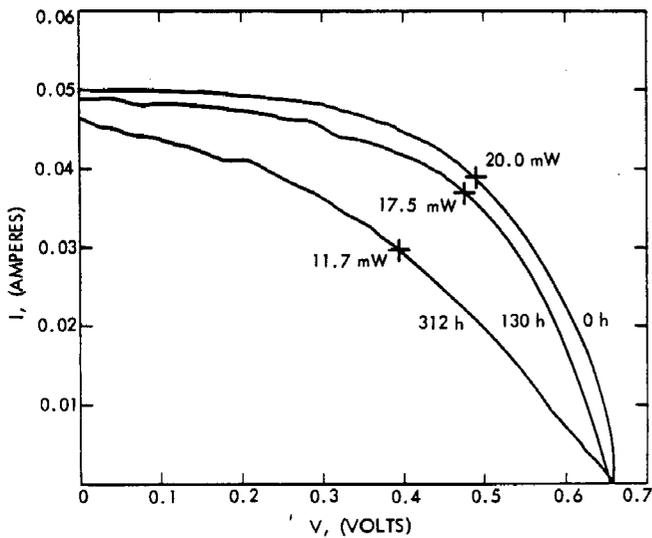
Figure 7. I-V Curves for Cell 6, Module A690E
85°C/85% RH, 500 volts

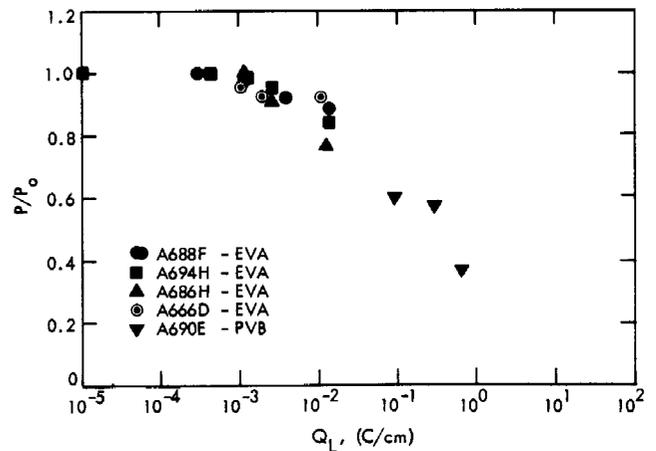
Figure 8. Power Output Reductions Versus Accumulated Unit Charge Transfer for Q-Si Cells

The importance of minimizing total charge transfer is made clear by the extensive levels of degradation observed with the PVB-encapsulated modules as they neared 300 hours of exposure. With a test-to-field acceleration ratio of three orders of magnitude, this degradation would correlate to sixty-some years of field exposure. The exact acceleration ratio is sensitive to the details of module construction that influence encapsulant moisture level and surface resistivity. A dry, foil-protected PVB has a lower electrical conductivity, but also a much lower acceleration factor in the 85°C/85% RH test environment.

Based upon gathered module power output versus charge transfer data, it is concluded that encapsulated α -Si cell degradation rates are somewhat greater than those of C-Si cells exposed to similar electrochemically active environments. However, when a good, high-resistivity corrosion-inhibiting encapsulant such as EVA is used, α -Si modules should have excellent long-term corrosion durability. A complicating factor making it more difficult to insulate monolithic thin-film cells

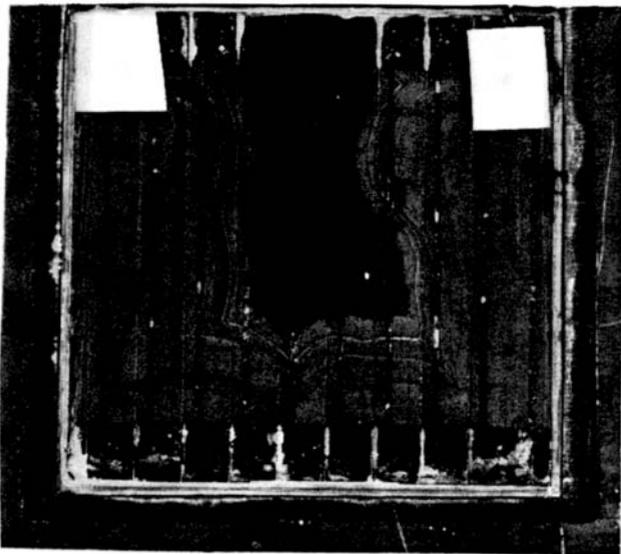
Negative polarity (Module 6) resulted in a moving corrosion/diffusion front as evidenced by successive ridges in the encapsulation (Figure 9). These ridges were formed by swelling and setting of the encapsulation upon sample removal from the ovens at various down-times; they are indicative of ion movement toward or away from the positive frame electrode. Loss of metallization and amorphous silicon was pronounced. White corrosion salts were also observed on the frame (anode).

Figure 9. Corrosion/Diffusion Fronts - Module 6

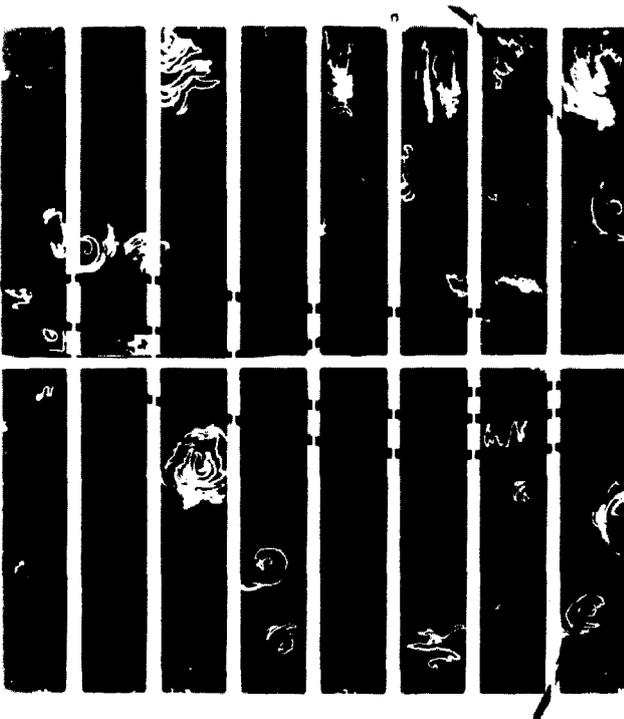
Positive polarity (Modules 7 and A690E) resulted in loss of aluminum cell metallization in squiggly, wormlike patterns (Figures 10 and 11). Electrode dissolution and ion diffusion are perhaps to be expected in this circumstance, but observation of these wormlike corrosion patterns is new.

The cause of the wormlike loss of metallization observed on PVB-encapsulated modules (Figures 10 and 11) is more elusive. The conclusion drawn from surface analysis of these configurations is that the thin aluminum layer is undergoing stress corrosion. The SEM micrograph (Figure 12) reveals the unique propagation pattern in the aluminum layer.

Figure 11. Stress Corrosion in Module A690E

To better understand the nature of α -Si module corrosion, several of the test samples were subjected to various surface and chemical analyses: A690E for Scanning Electron Microscopy (SEM) and Energy Dispersive X-ray Spectrometry (EDX) to determine the cause of the wormlike squiggly loss of aluminum metallization; A688F for SEM and EDX and Secondary Ion Mass Spectrometry (SIMS) to ascertain the cause of observed metallization discoloration; and Module 6 for SEM, EDX, SIMS, Fourier Transform Infra-red Spectroscopy (FTIR) and Ion Chromatography (IC) to reveal the nature of the anodic corrosion salts and to identify the species and direction of ion transport. The findings are as follows.

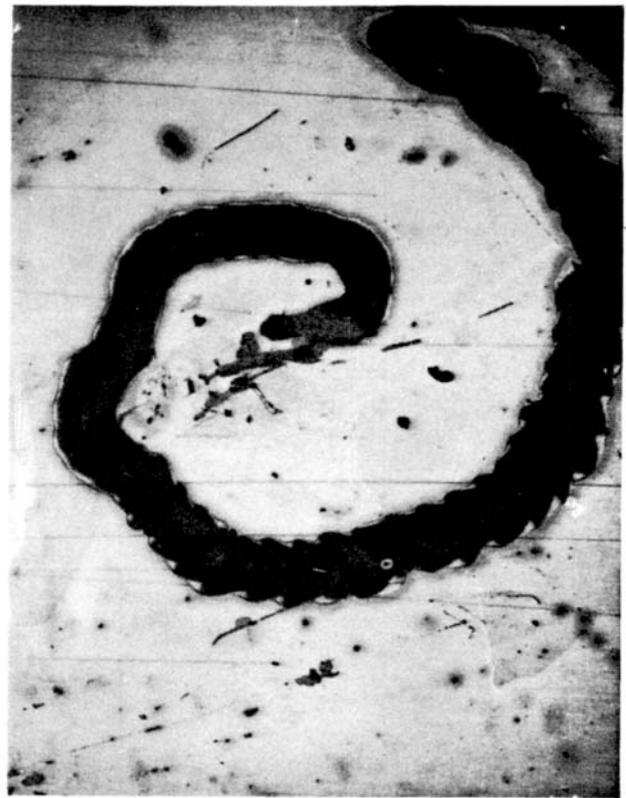
Figure 12. Wormlike Metallization Loss Pattern on Q-Si Module A690E, 40X

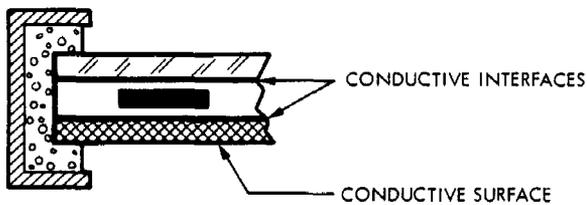
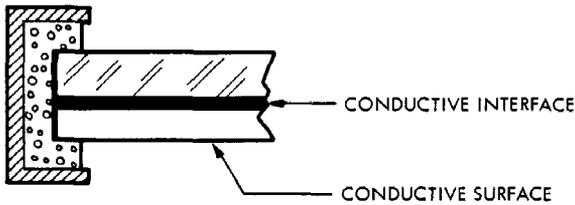
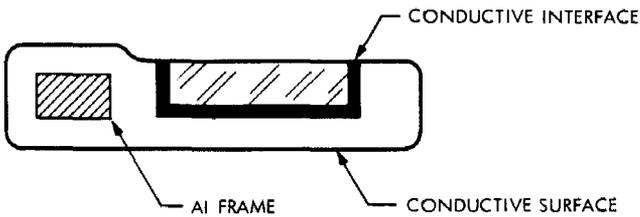
In contrast, typical commercial α -Si modules involving monolithic deposition on glass substrates, have no interface-free encapsulant isolating the cells from the module external surfaces. As shown in Figure 13, the cell-encapsulant interface provides an ionic conduction path directly to the module exterior, or to other cells of dissimilar voltage, in effect bypassing the encapsulant insulation. For such modules it would seem especially important to neutralize the ionic activity of this type of cell-encapsulant

A) TYPICAL C-Si MODULE

B) TYPICAL α -Si MODULE

C) α -Si TEST SPECIMEN

Figure 13. Module Schematics
